DEPARTMENT OF TRANSPORTATION**DIVISION OF ENGINEERING SERVICES**

Office of Structural Materials

Contract #: 04-0120F4Cty: SF/ALA Rte: 80 PM: 13.2/13.9File #: 99.28**WELDING INSPECTION REPORT****Resident Engineer:**Siegenthaler, Peter**Address:** 333 Burma Road**City:** Oakland, CA 94607**Report No:** WIR-024701**Date Inspected:** 13-Jun-2011**Project Name:** SAS Superstructure**OSM Arrival Time:** 700**Prime Contractor:** American Bridge/Fluor Enterprises, a JV**OSM Departure Time:** 1900**Contractor:** Zhenhua Port Machinery Company, Ltd (ZPMC) Chanxing Island**Location:** Shanghai, China**CWI Name:** Mr. SHI LIE**CWI Present:** Yes No**Inspected CWI report:** Yes No N/A**Rod Oven in Use:** Yes No N/A**Electrode to specification:** Yes No N/A**Weld Procedures Followed:** Yes No N/A**Qualified Welders:** Yes No N/A**Verified Joint Fit-up:** Yes No N/A**Approved Drawings:** Yes No N/A**Approved WPS:** Yes No N/A**Delayed / Cancelled:** Yes No N/A**Bridge No:** 34-0006**Component:** OBG Segment**Summary of Items Observed:**

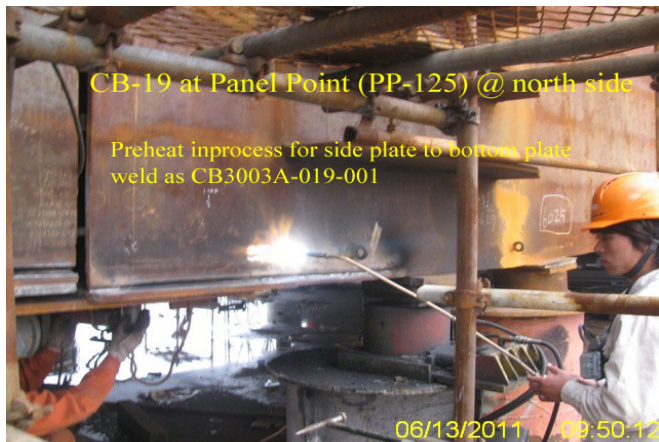
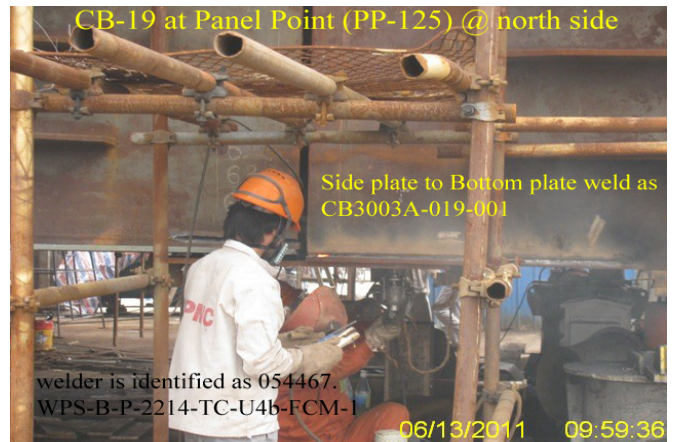
ZPMC welding personnel performing Shielded Metal Arc Welding of Complete Joint Penetration welds joining the side plate to bottom plate weld joint located on CB-19 at Panel Point (PP-125) @ north side. The weld is designated as CB3003A-019-001. The welder is identified as 054467. ZPMC QC Mr. LI YANG was onsite monitoring the welding variables. The inprocess Shielded Metal Arc Welding appears to be progressing in compliance with WPS-B-P-2214-TC-U4b-FCM-1. Further weld detail mention in attached picture.
